DARTMOOR EXPLORATION COMMITTEE, TWELFTH REPORT.

TWELFTH REPORT of the Committee, consisting of Mr. G. T. Harris, Mr. C. A. R. Radford, and Mr. R. H. Worth, for the purpose of exploring Dartmoor and the Camps of Devon.

BY R. HANSFORD WORTH.

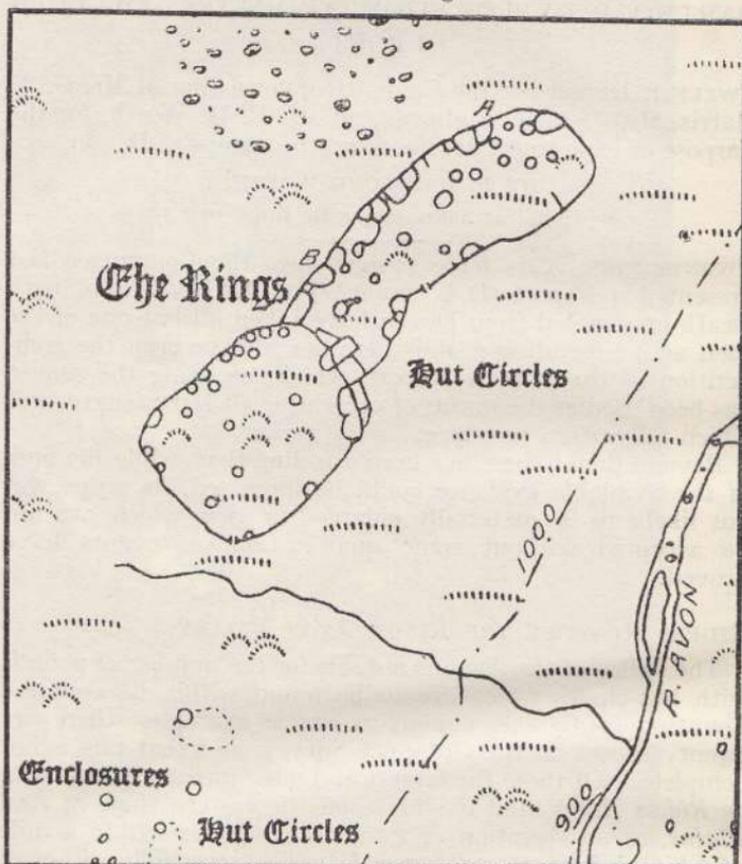
Fig. 1. PLAN OF RIDERS RINGS, scale 12 inches to 1 mile.
(adapted from the Ordnance Survey Map, with the sanction of the
Controller of H.M. Stationery Office).

able to give the time to make a complete survey, but reproduce as an approximation, and with the kind consent of the Director General of the Ordnance Survey, the plan as it appears on the Ordnance. Fig. 1.

As to that part of the pound which was investigated, I prepared and here insert a detail survey (Fig. 2). The length represented in this survey is that which lies between the points marked "A" and "B" on Fig. 1. It lies on the northern margin of the pound, and includes what would appear to have been the original entrance.

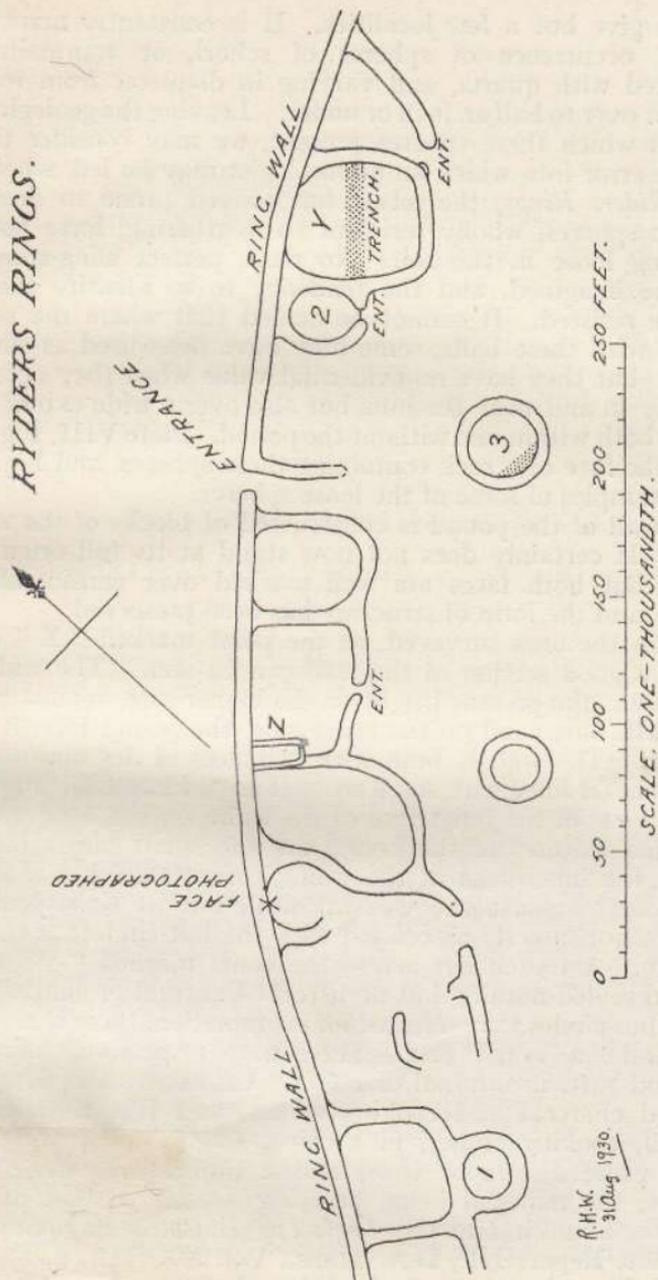
Fig. 2. DETAIL SURVEY OF PORTION OF RIDERS RINGS. B to A on fig. 1.

Within the area surveyed, at the point marked "X" on Fig. 2, a good section of the wall can be seen. The width is 6ft. 8ins., the present height on the higher side, against the hill, is 2ft. 6ins., and on the lower side, the pound face, it is 3ft. 6ins. The wall is built with two faces of dry masonry, and the heart filled with small stone (Fig. 5, Plate IX). Fig. 6 gives a view of the inner face of the wall.

Marked features of the pound are the small courts built against the inner face of the wall. *Grimspound* has a few such courts against the western wall, but at *Grimspound* they are not directly associated with the hut-circles, as they are here. A trench cut across the court marked "Y" on Fig. 2 revealed nothing but undisturbed natural ground.

Two hut circles were selected for examination, those marked "1" and "2" on Fig. 2. These were respectively about 20ft. and 24ft. in internal diameter. On excavation, Hut 1 returned charcoal and cooking stones, and Hut 2 yielded charcoal, cooking stones, flint chips, fragments of pottery of the usual Dartmoor type, and a broken whetstone in red grit, the material being precisely similar to that of a whetstone found in Hut viij, *Legis Tor* (*Dartmoor Exploration Committee, Report III.*, D.A. Trans., Vol. XXVIII., p. 179). Plate X, Fig. 7 is a photograph of this whetstone.

At *Riders Rings* a small square building of dry masonry has been erected, doubtless as a shelter at some not very remote date. It is indicated by the letter "Z" on Fig. 2, and its dimensions are 18ft. 6ins. by 6ft. 6ins.

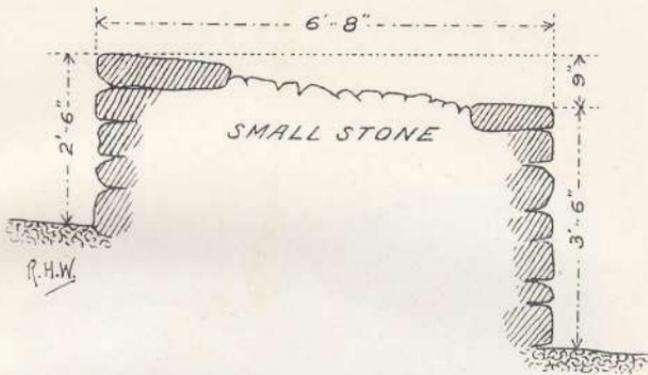
Fig. 5. RIDERS RINGS, SECTION OF POUND WALL.

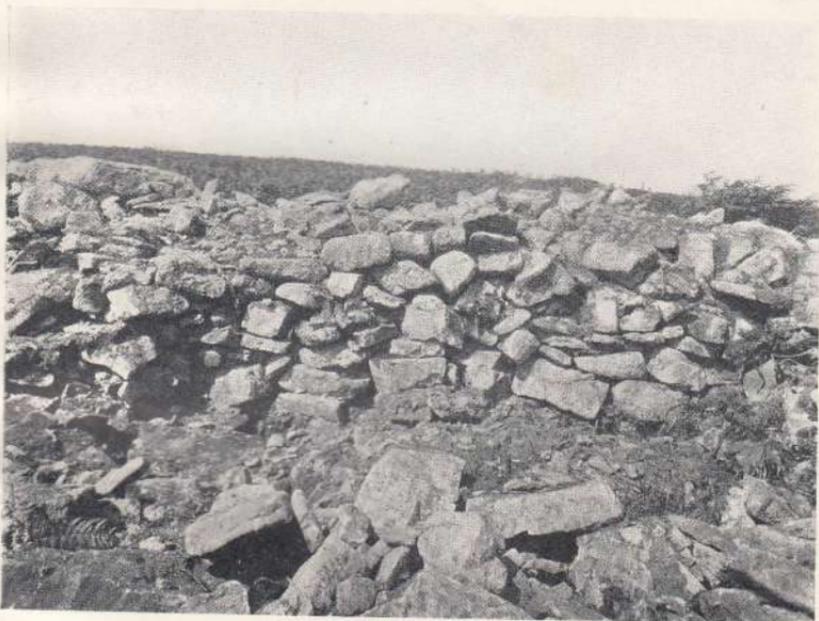
Fig. 6. RIDERS RINGS, INNER FACE OF POUND WALL.

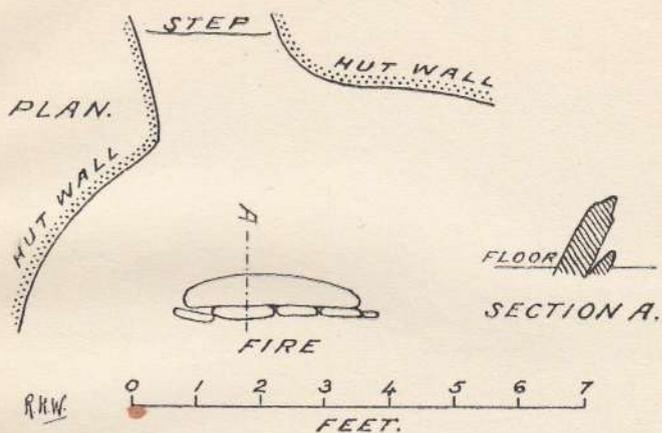
Fig. 8. PLAN OF FIREPLACE, HUT 2, RIDERS RINGS.

feet within this step there stood a granite slab, erect on edge, a little under 3ft. in length, standing 13ins. above the floor of the Hut, and leaning slightly inward. This had been carefully trigged on the side toward the centre of the Hut with small flat stones. Against the slab, and extending some little way toward the centre of the Hut, there had evidently been one of the fireplaces, represented by a shallow pit, filled with charcoal and ash. No such fire facing an entrance and similarly screened from draught has been found in any other Dartmoor circle. Fig. 8, Plate XI provides a plan and section of this fireplace, and Fig. 9, Plate XII is a photograph of the upstanding slab.

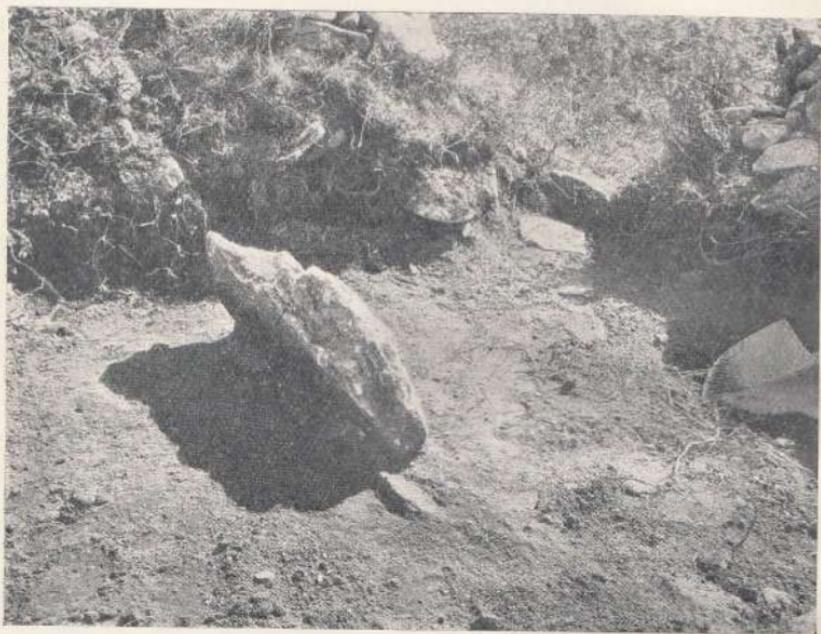
Fig. 9. VIEW OF FIRE-PLACE, HUT 2, RIDERS RINGS.

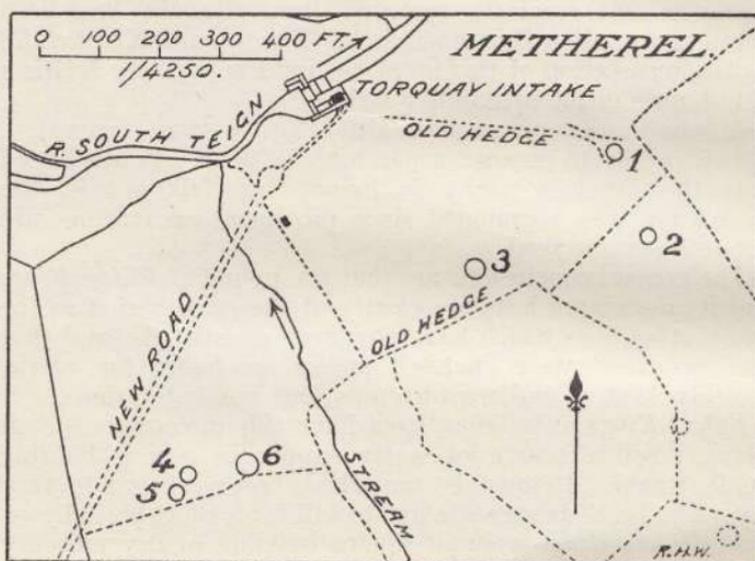
Fig. 10. GENERAL PLAN, METHERELL.

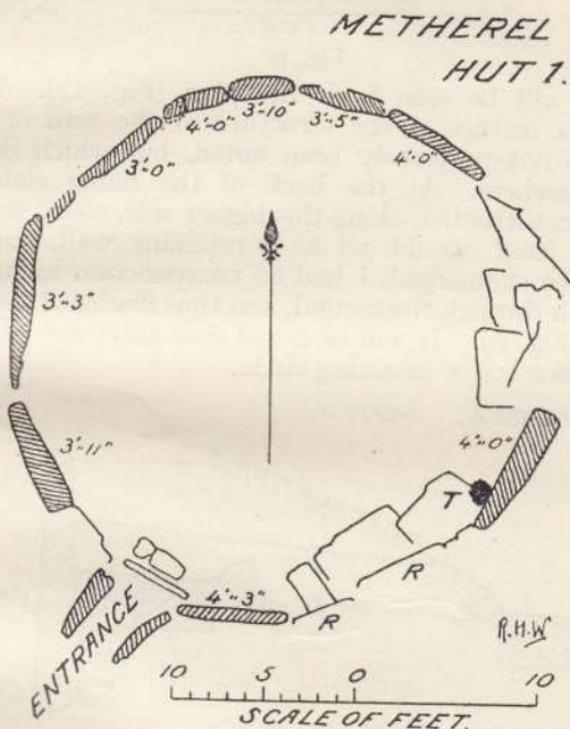
Fig. 11.

HUT 1, at the head of the two hedges, is 28ft. in diameter within its walls. Large slabs, one as long as 10ft., line the inner face of the wall, but their height is not great, ranging from 3ft. to 4ft. The entrance lies to the south-west, and was readily identified. Its clear width is greater than usual, being 2ft. 9ins.; its height is 3ft. 9ins. It is formed by two slabs which extend through the thickness of the wall. The entrance has been paved, and there are two steps down to the floor of the hut. Fig. 11 gives a general plan of Hut 1, and Fig. 12 a plan and section of the entrance.

down, as will be seen from the plan (Fig. 11). The fall disclosed a feature of the structure of the wall or mound which has not previously been noted, but which doubtless occurs elsewhere. At the back of the lining slabs there had been constructed, along this higher side, a dry stone wall which, in itself, would act as a retaining wall. Since the hut is to be submerged, I had no compunction in running a trial trench through the mound, and thus disclosed the section shown in Fig. 13. It will be noted that there are also stones disposed as a toe or retaining circle.

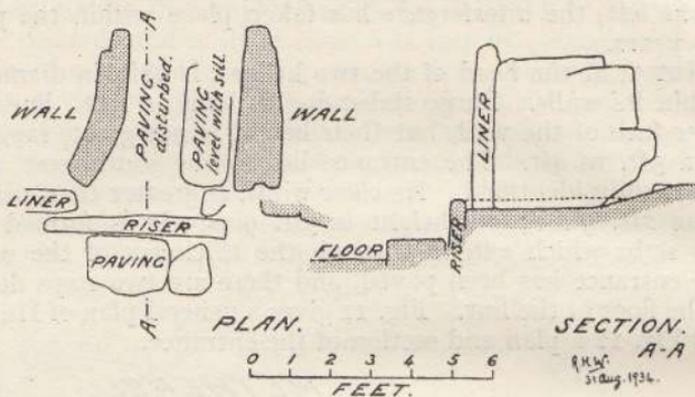
Fig. 12.

METHERELL, ENTRANCE HUT 1.

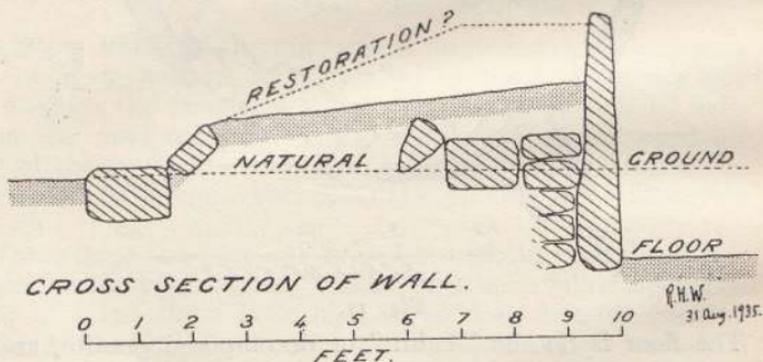
Fig. 13. STRUCTURE OF HUT WALL.

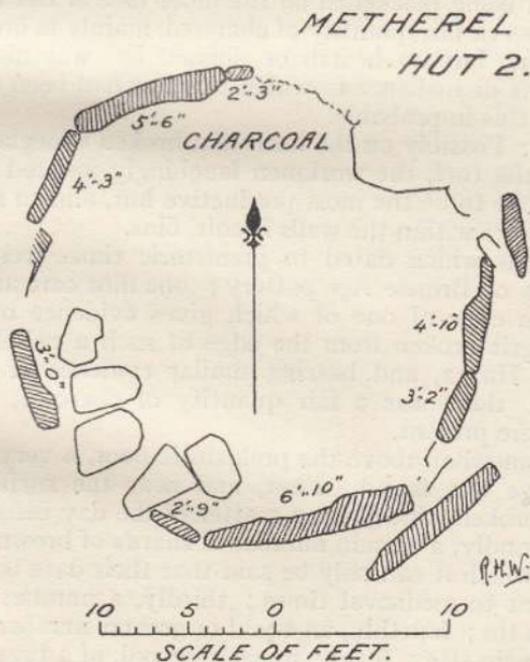
Fig. 15.

Great disturbance had been caused to this hut by the quarrymen; many stones had obviously been broken up, and the floor was deep in a layer of spalls. So great had been the disturbance that the site of the entrance could not be ascertained. It was here that the stone with the jumper-holes was found, which dates the interference as relatively recent. Fig. 15 is a plan of Hut 2.

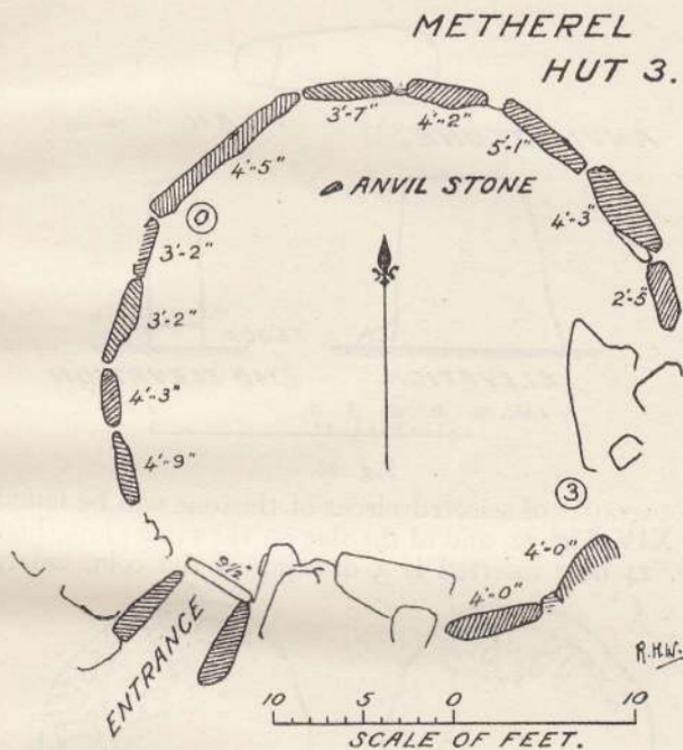
Fig. 19.

height, 15ins. in length, and $5\frac{1}{2}$ ins. in greatest thickness, the rounded top of which bears marks of abrasion, as if it had been used as an anvil. It was near this stone that the broken slag lay thickest; and it may be that the slag was broken on the stone. The position of this stone is shewn in Fig. 19, and marked Anvil. Fig. 20 gives details of the "anvil," and Plate XIII, Fig. 21 gives views.

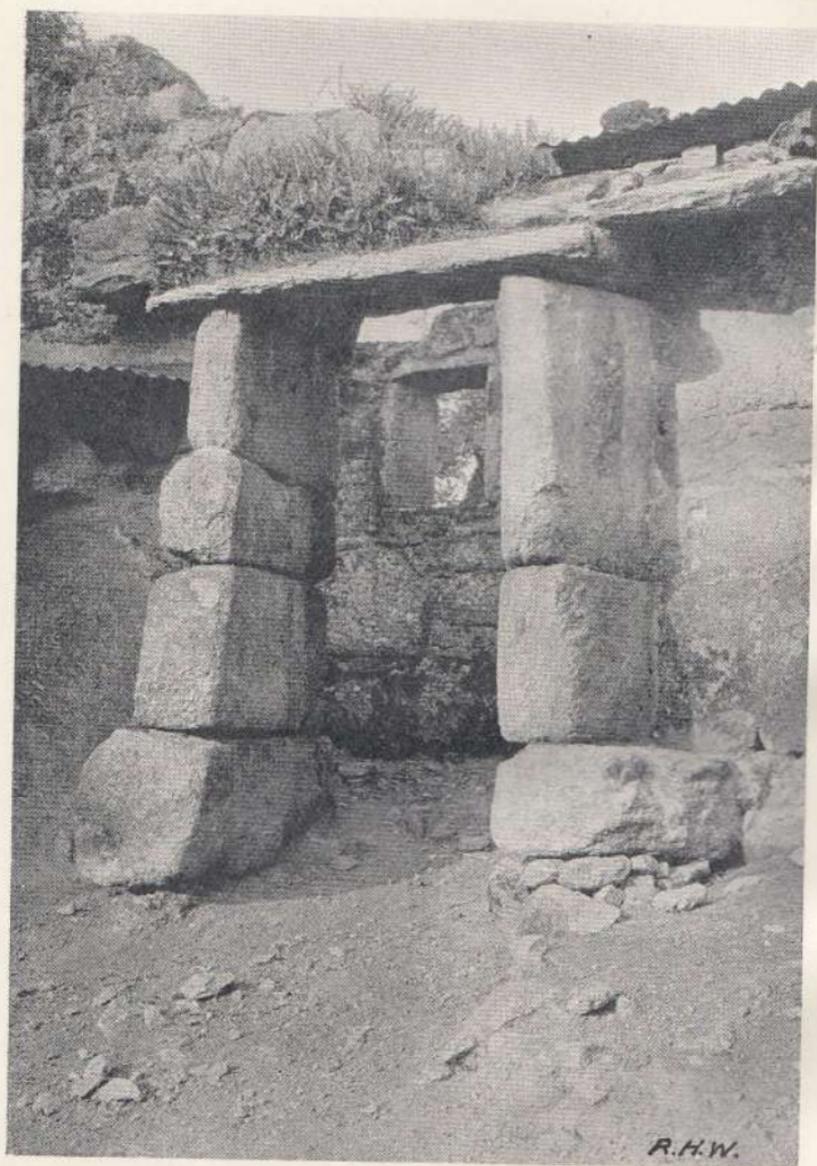
Fig. 25. PORCH, OLD YARDWORTHY.

The dominant feature of the building is a granite porch of a very early type. Its construction is of the simplest, slab superimposed on slab in either wall, and a single slab for the roof. This strikes the note of primitiveness, and closer examination shows that the door which closed this porch had no frame, but hung from granite wall to granite wall; turning, not upon hinges, but upon a projection at the head of the hanging style engaging in a hole in the roof slab, and doubtless another such projection at the foot, engaging in a hole in the sill (the sill has been lost). The sides of the porch converge to the entrance, and are dressed to receive the door. The door did not stand parallel to the front of the house, or at equal angles with the sides of the porch. A view of this porch is given in Plate XV, Fig. 25, and full details are shown in Fig. 26, here inserted. (See also Plate XVIII, Fig. 32).

The window which can be seen in the far wall, through the doorway in Fig. 25, is consistent with the porch. It has never been glazed, but was closed by a wooden shutter, hung as described for the porch door. In this instance the granite sill is still left and the hole in which the shutter turned may be seen. A view of this window opening, taken from the outside, is given in Plate XVI, Fig. 27, and Fig. 28, Plate XVII supplies an elevation and plan.

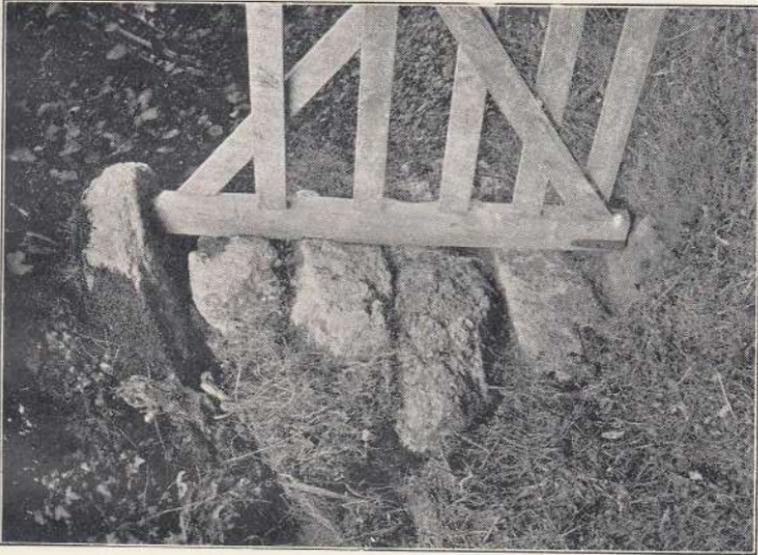
R. H. Worth.
Fig. 29. GATE-HANGING, WORMHILL.

This method of hanging gates and doors has remained in use to the present day in the matter of gates. There is still a gate on *North Harton Farm*, at the north of *Lustleigh Cleave*, which is so hung, and until the last year or so there was a similar gate at *Wormhill* by the side of a public road. (See Plate XVI, Fig. 29 for a view of the *Wormhill Gate*).

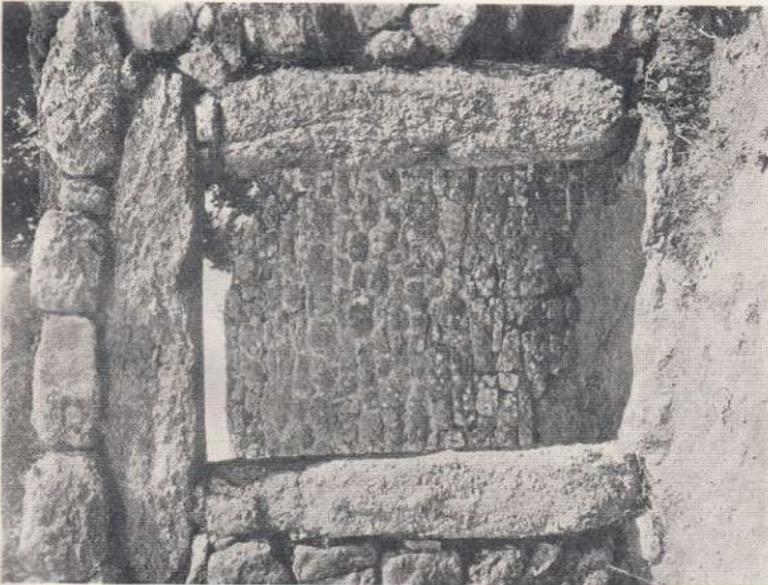
R. H. Worth.
Fig. 27. WINDOW, OLD YARDWORTHY.

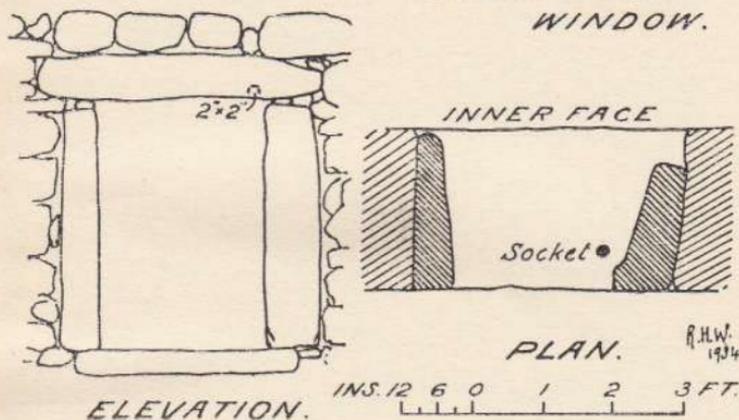
Fig. 28.

YARDWORTHY.
WINDOW.

WINDOW, sill 4 inches above ground.

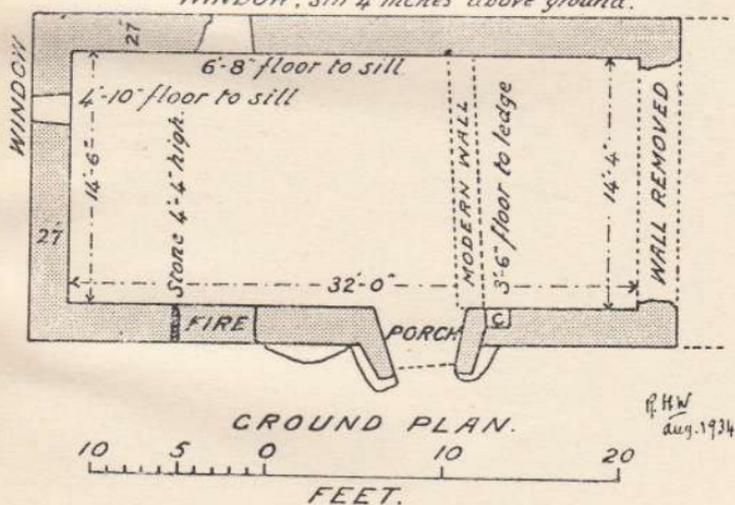
Fig. 30.

The internal dimensions of this old house are 32ft. by between 14ft. 6ins. and 14ft. 3ins. The length is significant, as being double the linear perch of the twelfth century, a measure which doubtless lingered on into the thirteenth and fourteenth centuries for building purposes (Plate XVII, Fig. 30).

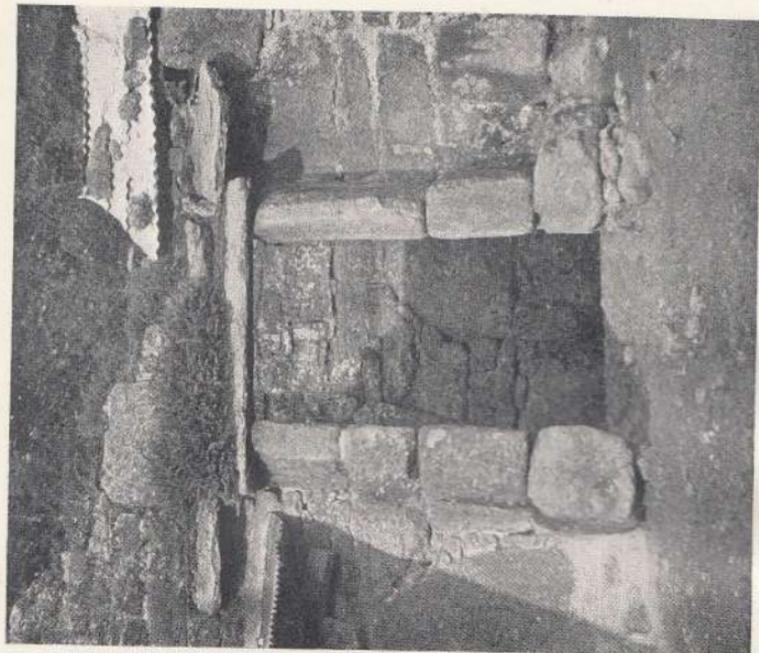
R. H. Worth.
Fig. 32. PORCH, OLD YARDWORTHY.

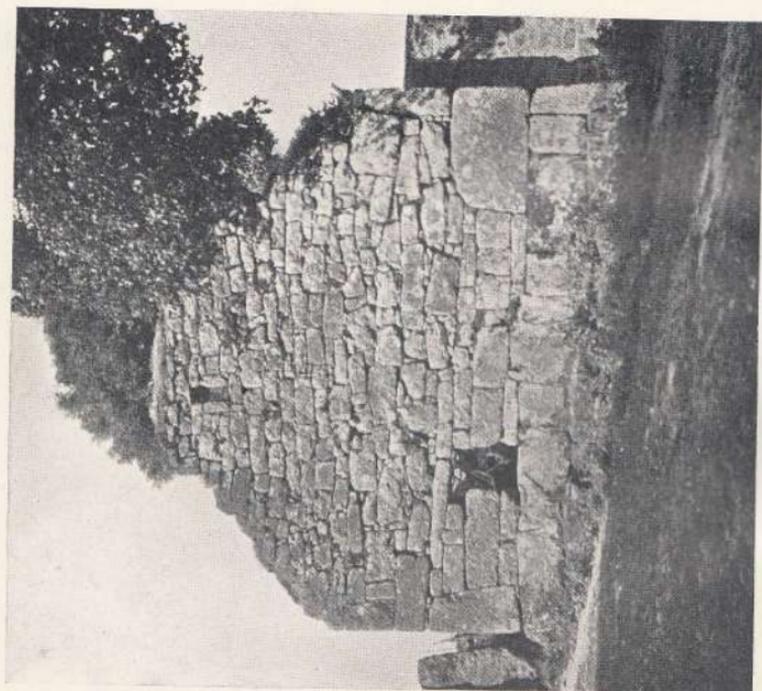
R. H. Worth.
Fig. 31. SOUTH GABLE, OLD YARDWORTHY.

There is a small window in the south end wall, the sill being 4ft. 10ins. above the floor level; and there is an opening in the gable which may indicate that there was an upper floor or tallet, although no provision for floor joists can be traced in the walls. Indeed there is no evidence of internal partitions of any sort, but the absence of such evidence is not conclusive that there were none; partitions may well have been formed of framed and panelled oak, many such survive in farms and houses of a later date.

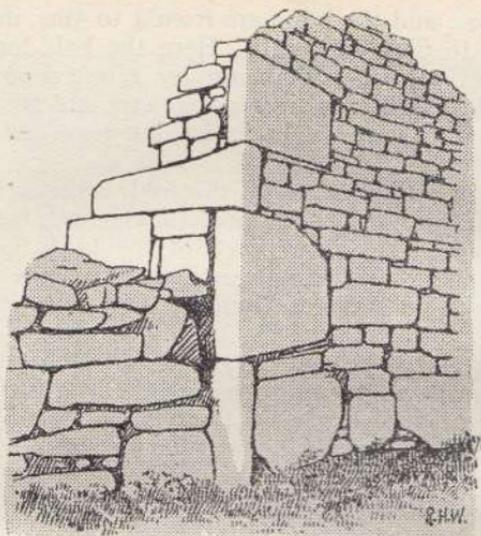
Fig. 33. BROAD AND NARROW WORK QUOIN, CHALLACOMBE.

The masonry of uncoursed rubble is set in good mortar, and the walls are but 27 inches in thickness, they are still sound, lacking but a roof for their security for many years. The main quoins are built in a variation of the "long and short" work, sometimes, but probably erroneously, described as of Saxon date. In place of slabs placed on flat alternating with blocks set on end, the quoins here consist of slabs set on edge, their broad faces alternating on either side of the angle. Such slabs are necessarily "shiners," faces of perhaps 5ft. by 4ft., standing on beds no more than 5ft. by 9ins., the stone not even extending through half the thickness of the wall. The photographic elevation of the south gable wall (Plate XVIII, Fig. 31) shows this form of construction clearly. It may be assumed to be faulty, but the proof of its soundness lies in its endurance. Other examples may be found on Dartmoor,

for instance in an old building at *Challacombe* near *Headland Warren*, and in another at *Rushlade, Ashburton*. A sketch of the quoin at *Challacombe* is here inserted, Fig. 33.
