## THIRTY-FIFTH REPORT OF THE BARROW COMMITTEE.

THIRTY-FIFTH REPORT of the Committee—consisting of the Rev. S. Baring-Gould, Mr. R. Burnard, the Rev. J. F. Chanter and Mr. R. Hansford Worth (Secretary)—appointed to collect and record facts relating to Barrows in Devonshire, and to take steps, where possible, for their investigation.

### BRISWORTHY STONE CIRCLE.

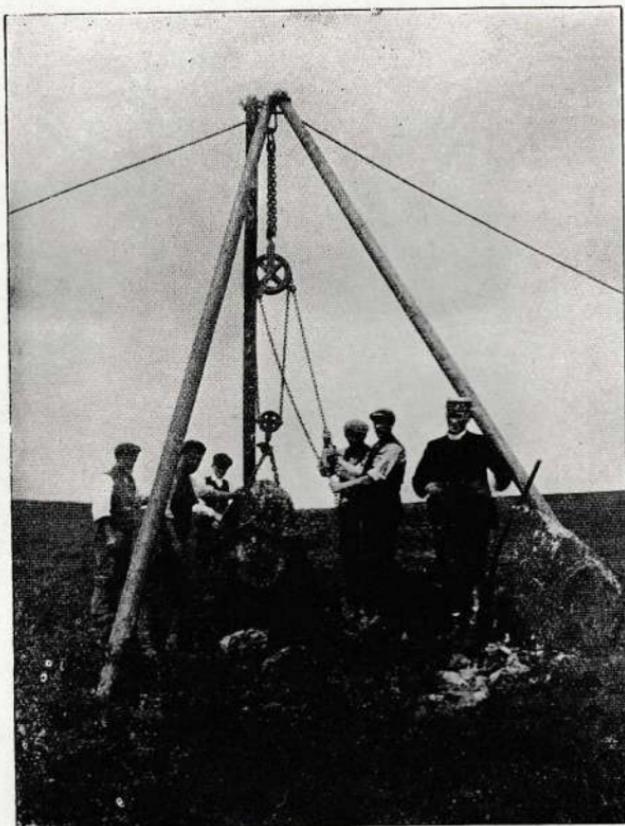
*Photo, R. H. Worth.*  
RE-ERECTING BRISWORTHY CIRCLE.

Judging by the most perfect portions of the circumference the stones were originally six feet apart from centre to centre, and accordingly there would have been about forty-two before the monument was robbed. Twenty-two are now left. These have been carefully re-erected; most were put up by hand, but one required the use of sheer-legs. By the courtesy of the Rev. H. H. Breton a block showing this pillar in course of re-erection is here inserted.

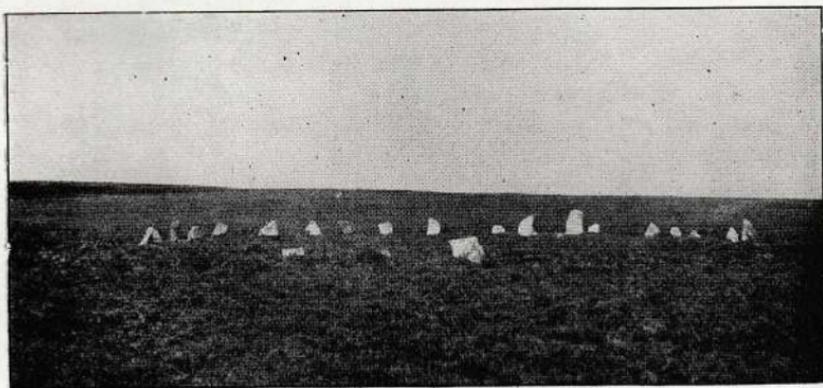
*Photo, Rev. H. H. Bixton.*  
BRISWORTHY CIRCLE AFTER RESTORATION.  
VIEW—LOOKING N.W.

Brisworthy Circle was carefully restored in the year 1909, the Rev. H. H. Breton, of Sheepstor, being the initiator of the restoration, and the Rev. S. Baring-Gould, Mr. R. Burnard, and the Secretary of your Committee being present at various times while the work was in progress.

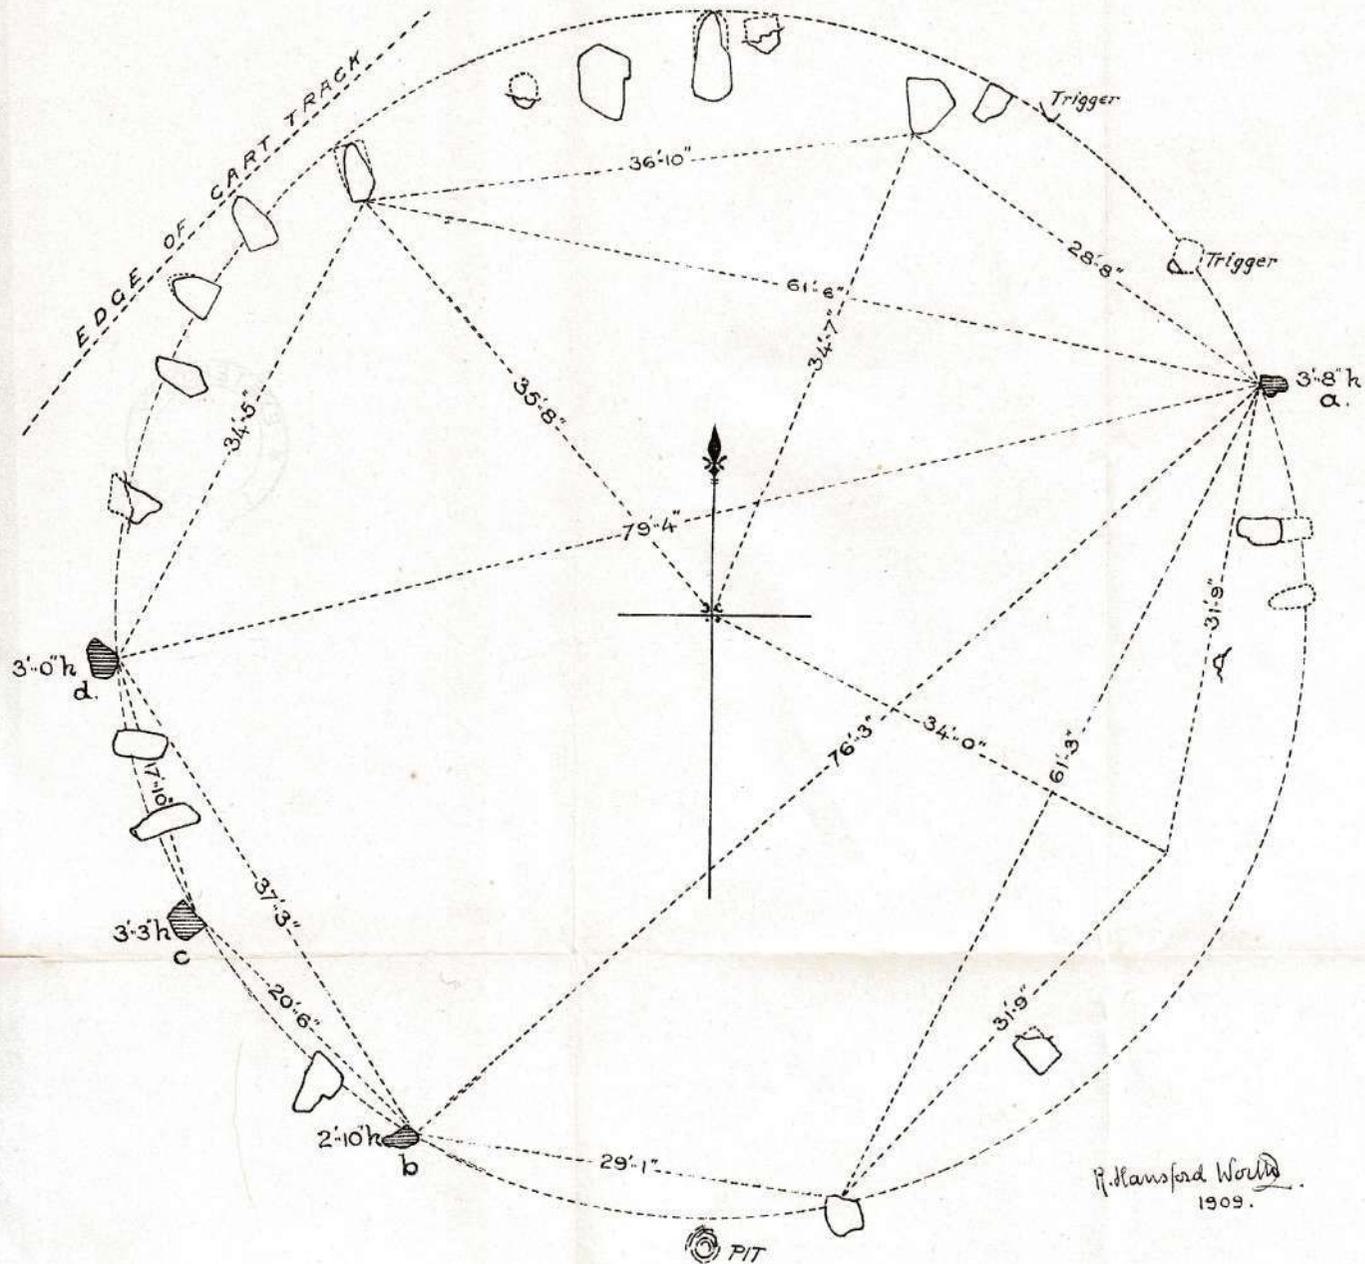
# BRISWORTHY CIRCLE

On the plan herewith, the dotted circle has a diameter of eighty feet, and it will be seen that it just touches the three stones on the west and the one stone on the east that were still standing (standing stones are indicated by hatching). It would appear that the internal diameter of the circle as originally constructed was eighty feet. The standing stones were somewhat massive, and the highest (on the east) stood 3 ft. 8 ins. above ground.

Of fallen stones, undoubted members of the circle, there were eighteen, while the positions of two others were indicated by "triggers" and of one more by a pit.

On the plan, such portions of the stones as were buried beneath the turf are indicated by dotted lines.

There is a stone fence to the south of the circle, and the southern half has been robbed of nearly all its members, a fact which is something more than a coincidence; one stone on this southern side had been cut in two and a part only taken away.
